TECHNICAL REPORT CERC-90-7

KING HARBOR, REDONDO BEACH, CALIFORNIA, BREAKWATER STABILITY STUDY

Hydraulic Model Investigation

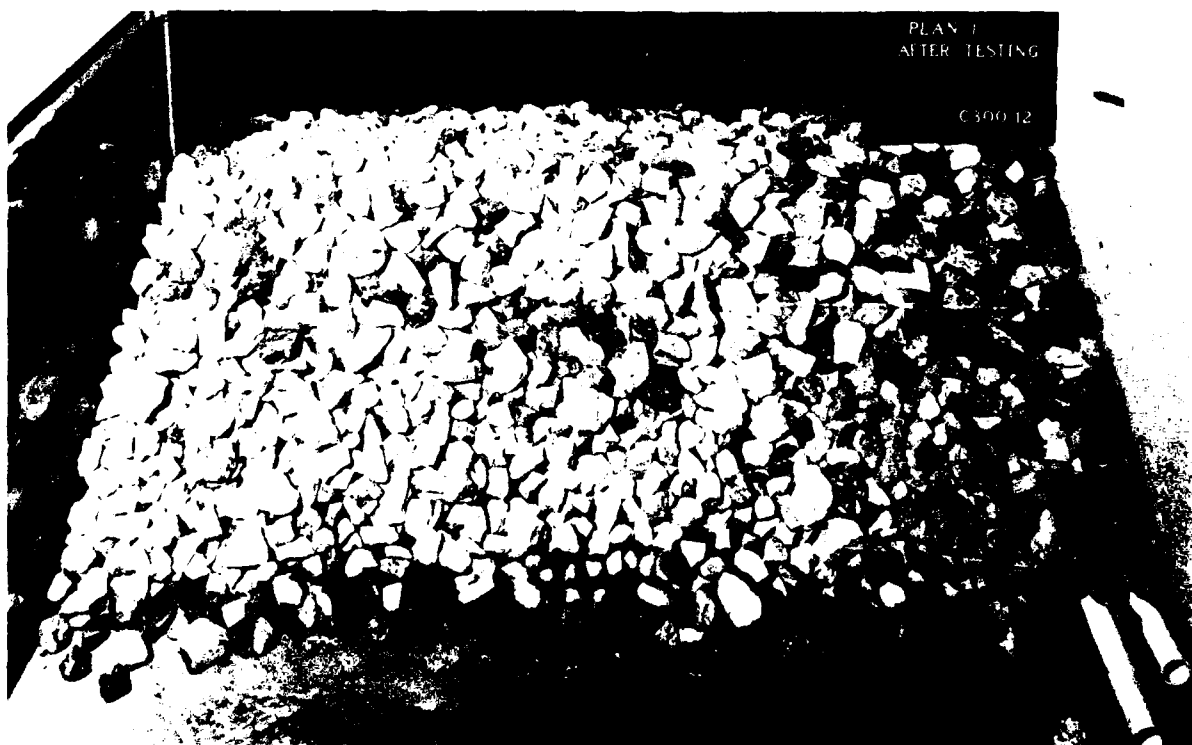
Photo 4. Plan 1, after testing, side view

Photo 5. Plan 1, after testing, sea-side view

Photo 6. Plan 1, after testing, harbor-side view

23. Plan 1 (Figure 4, Photos 1-6), proposed by SPL, consisted of raising the crest elevation to +20 ft mllw by adding one layer of 11- to 19-ton stone ("A" Stone) to the existing crest, adding two layers of "A" Stone to the harbor side slope from -10 ft mllw to the crest, and placing 3- to 8-ton stone ("A-2" Stone) to -10 ft mllw from the base of the breakwater on the harbor side to form a toe buttress. Placement of armor units on the harbor side at King Harbor is more economical because shallower water depths result in less armor stone required and armor stone placement by ocean-borne construction equipment is protected by the breakwater.

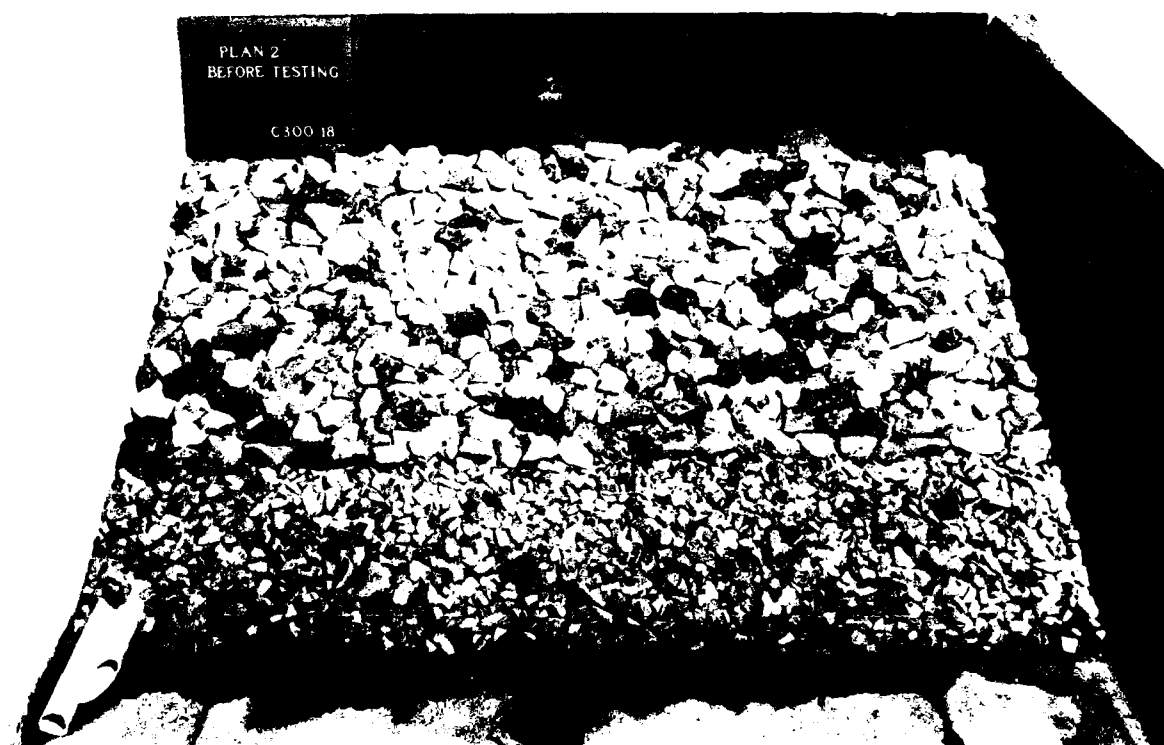
Photo 7. Plan 2, before testing, side view

Photo 8. Plan 2, before testing, sea-side view

Photo 9. Plan 2, before testing, harbor-side view

27. Plan 2 consisted of the same geometric cross section as Plan 1, but 6- to 11-ton armor stone ("A-1" Stone) was placed from +10 ft mllw to -10 ft mllw, with "A" Stone placed from +10 ft mllw to the crown on the harbor side (Figure 8, Photos 7-12). "A-1" Stone was chosen by SPL as the most economical armor size to replace the larger armor units. The toe buttress was composed of "A-2" Stone, identical to Plan 1.

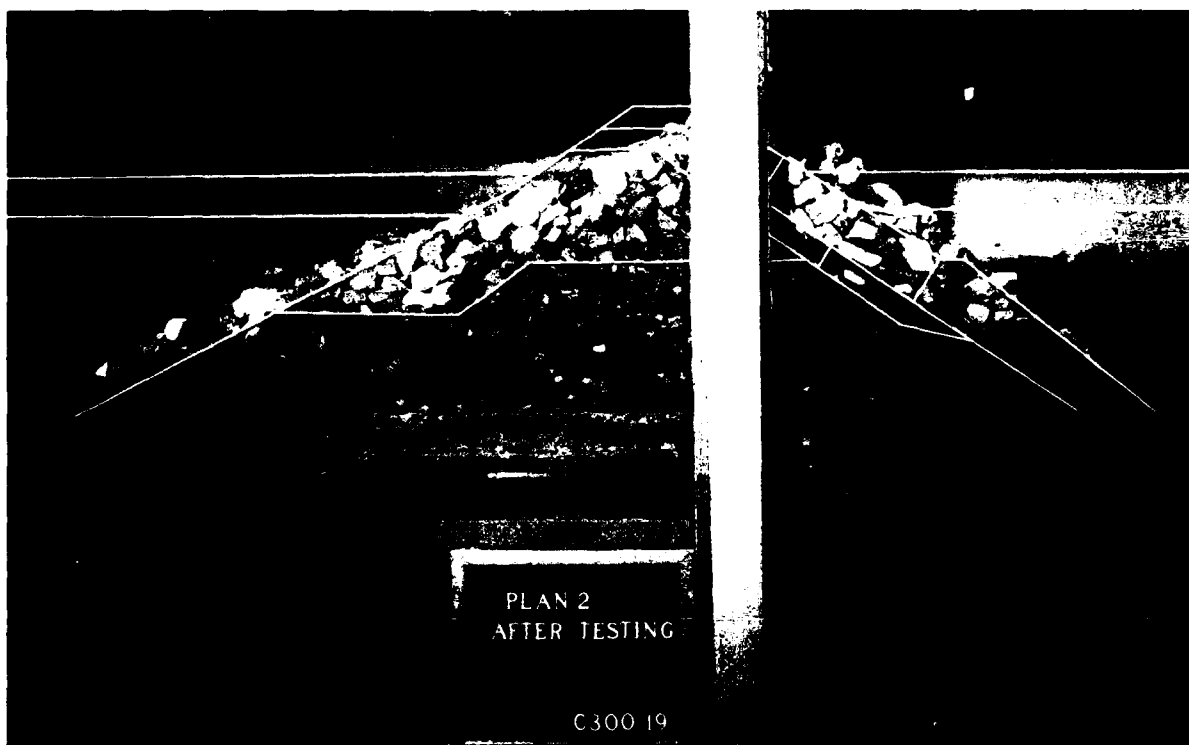
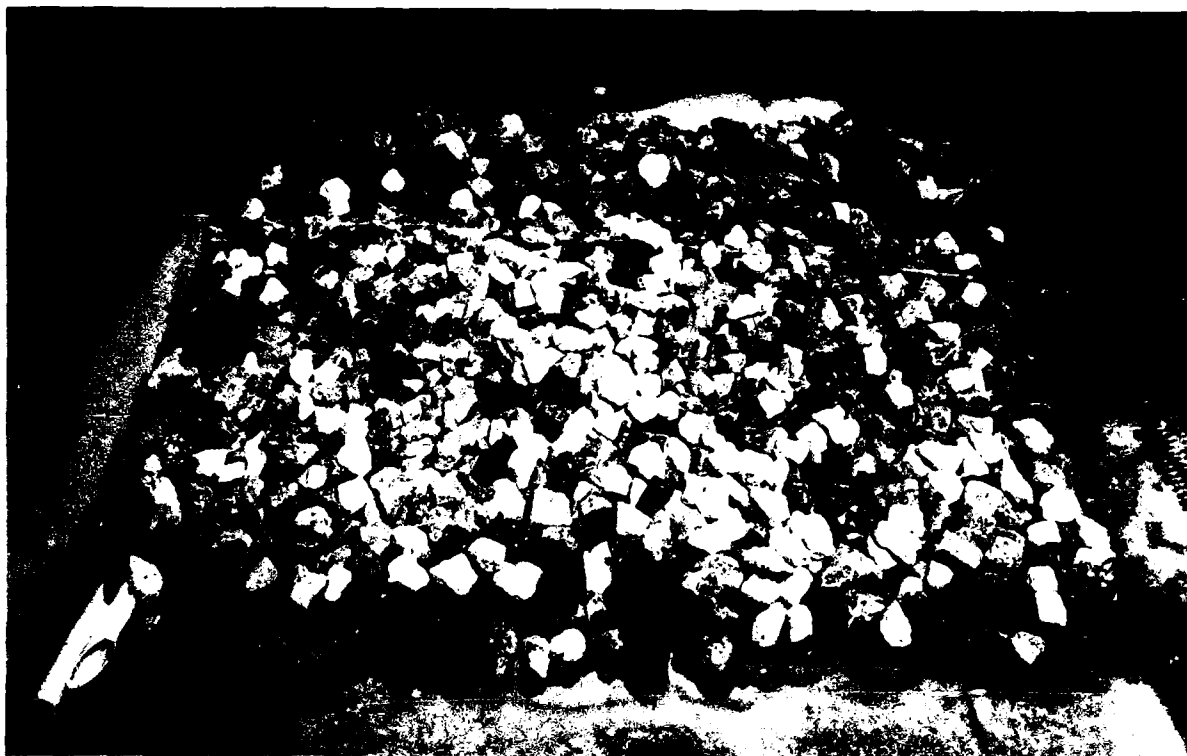
Photo 10. Plan 2, after testing, side view

Photo 11. Plan 2, after testing, sea-side view

Photo 12. Plan 2, after testing, harbor-side view

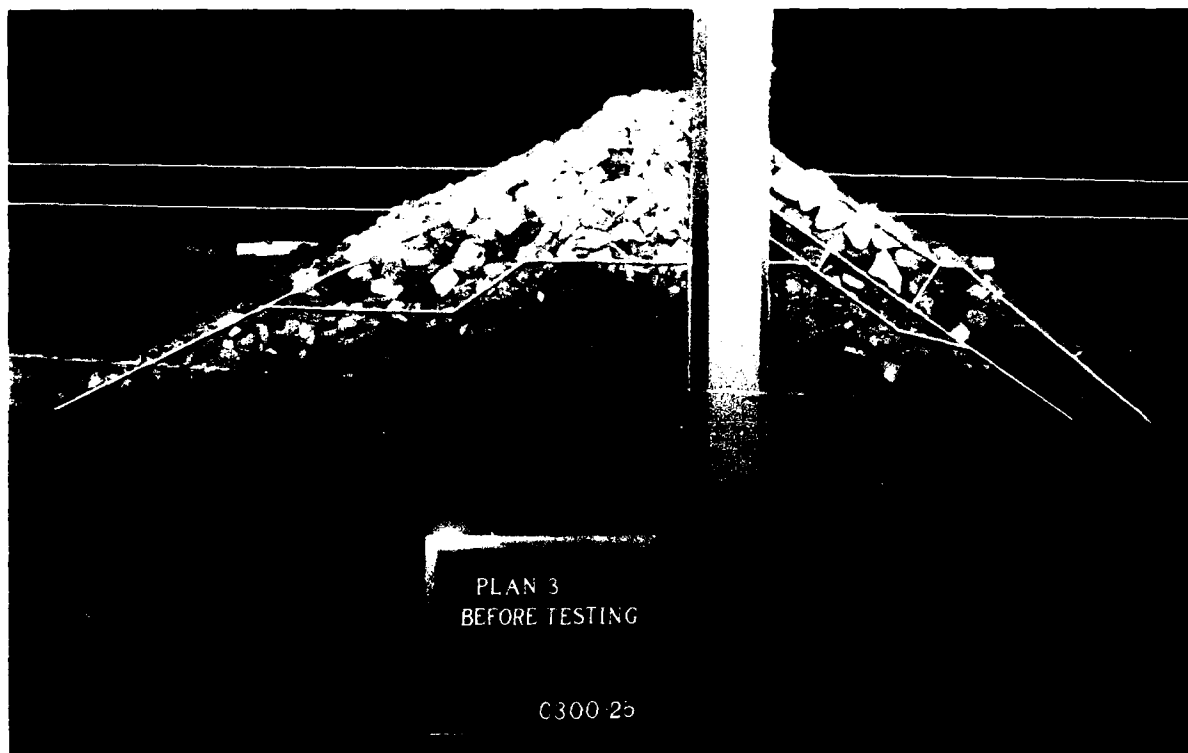
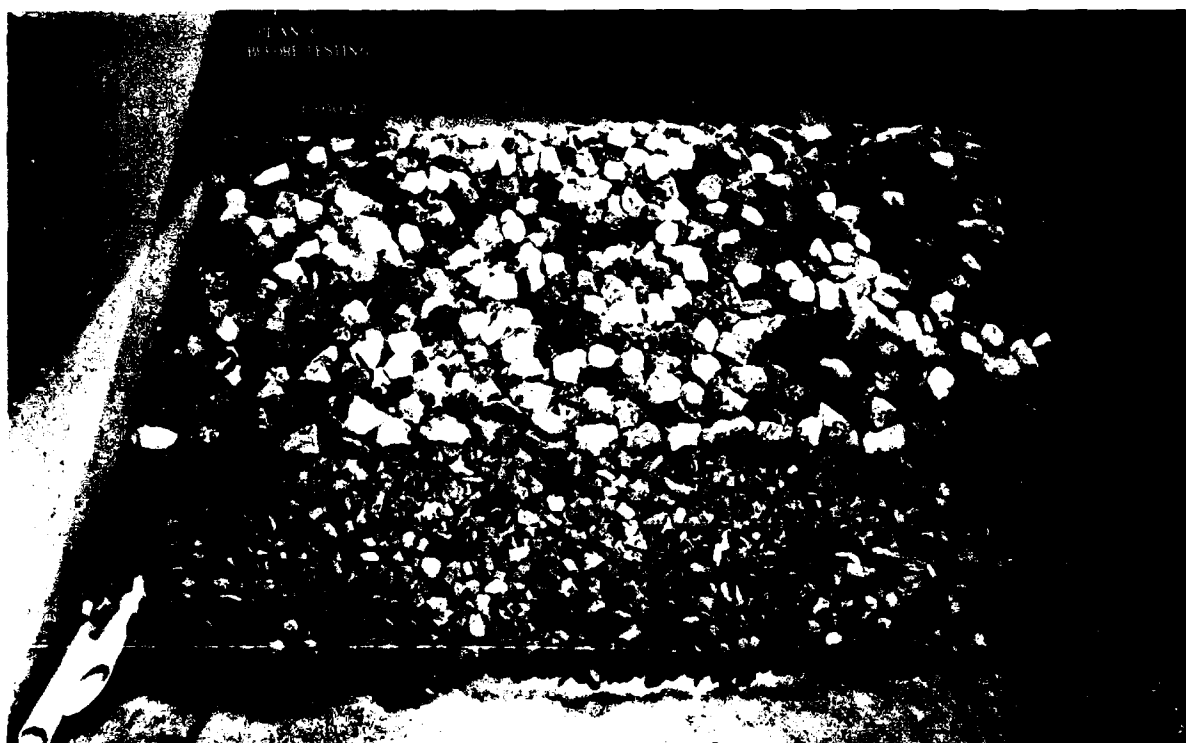
Photo 13. Plan 3, before testing, side view

Photo 14. Plan 3, before testing, sea-side view

Photo 15. Plan 3, before testing, harbor-side view

31. Results from Plan 2 indicated that the "A-1" Stone was stable for all waves if placed on the middle section of the harbor side; "A" Stone in the upper section was stable for $(H_{mo})_i < 22$ ft ; and stability tests with smaller armor stone placed in the upper section might be stable. Plan 3 (Figure 13, Photos 13-18) consisted of the same geometry as Plan 1, except "A-1" Stone was placed on the harbor-side slope from the breakwater crest to -10 ft mllw. The harbor-side toe buttress remained the same as previous plans.

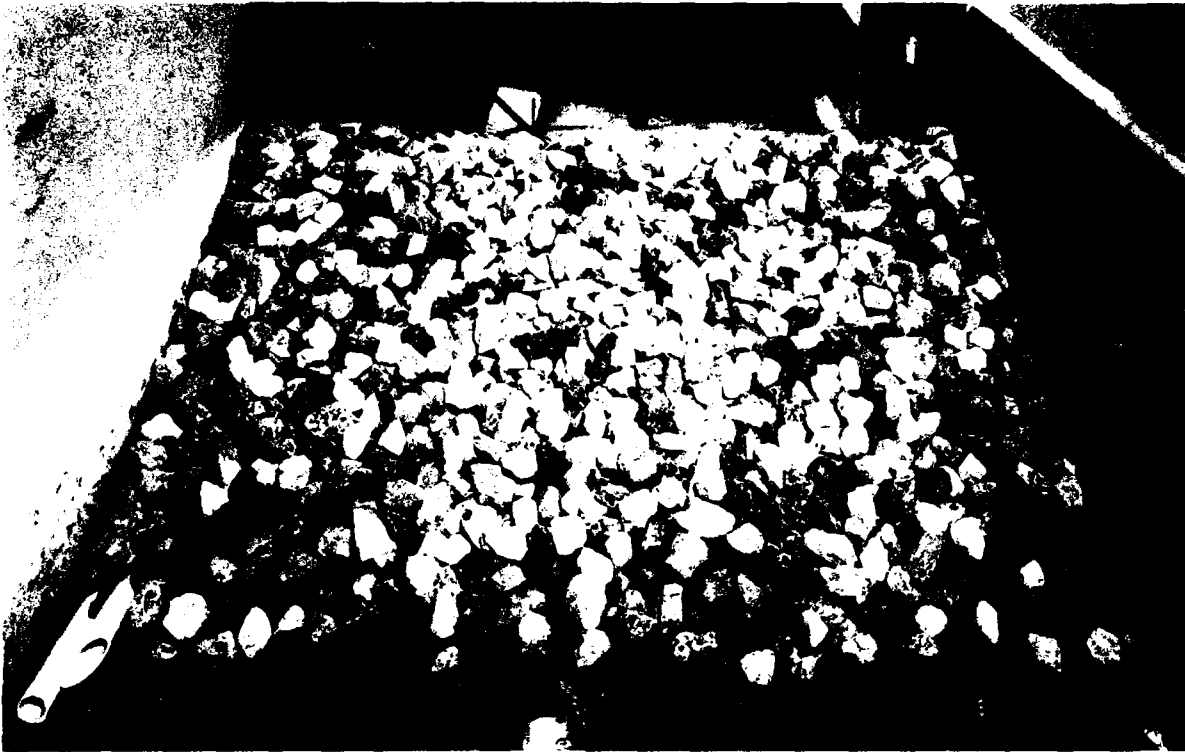
Photo 17. Plan 3, after testing, sea-side view

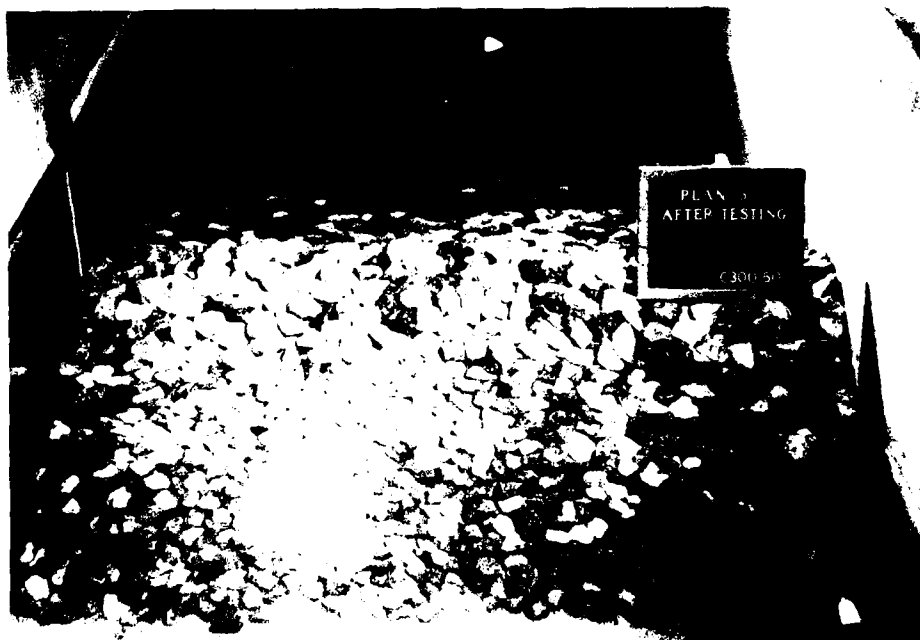
Photo 24. Plan 5, after 13-ft waves, harbor-side view

41. Plan 5 (Figure 22, Photos 19-33) was similar to Plan 4 but consisted of a 10-ft-thick transition layer of 200- to 2,000-lb stone ("T-1" Stone). The armor layers on the harbor side were the same as in Plan 4.

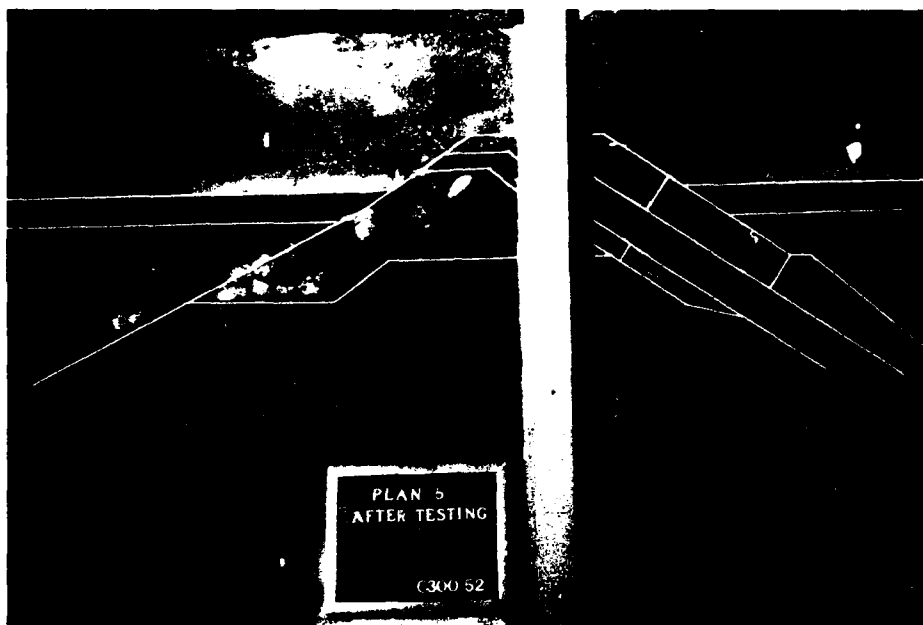
Photo 25. Plan 5, after 16-ft waves, side view

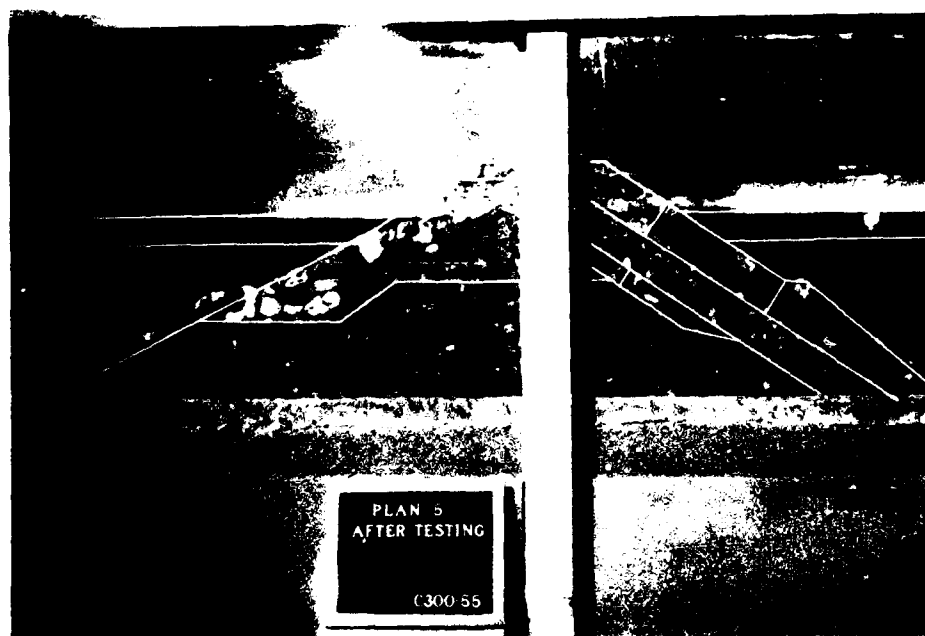
Photo 28. Plan 5, after 20-ft waves, side view

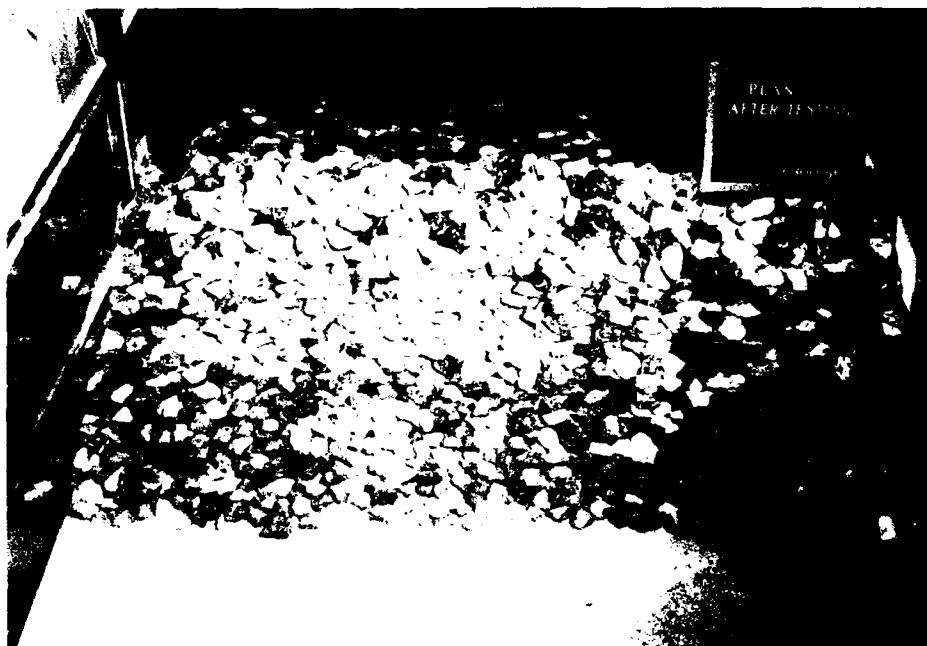
Photo 30. Plan 5, after 20-ft waves, harbor-side view

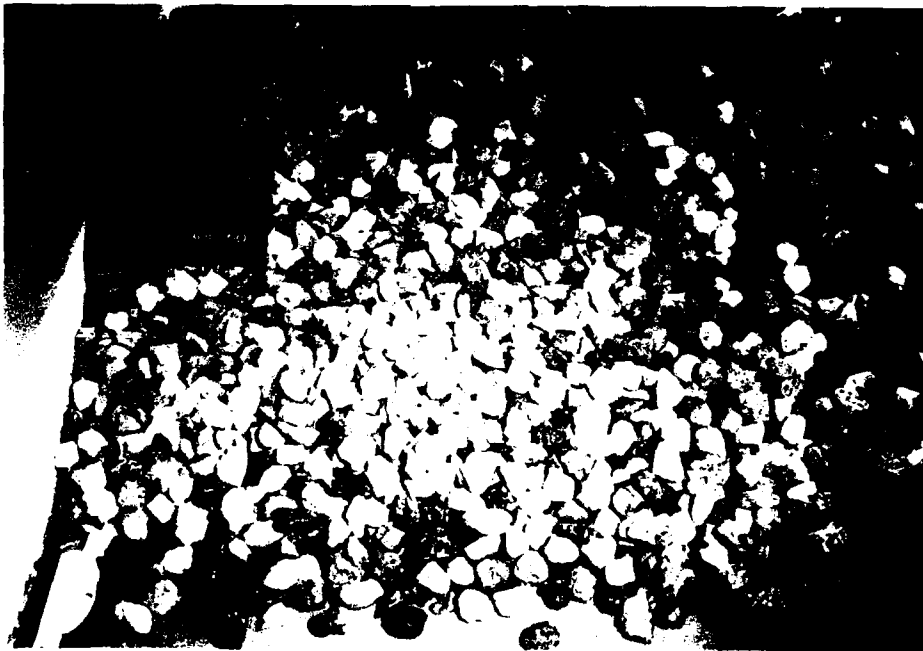
Photo 32. Plan 5, after 24-ft waves, sea-side view

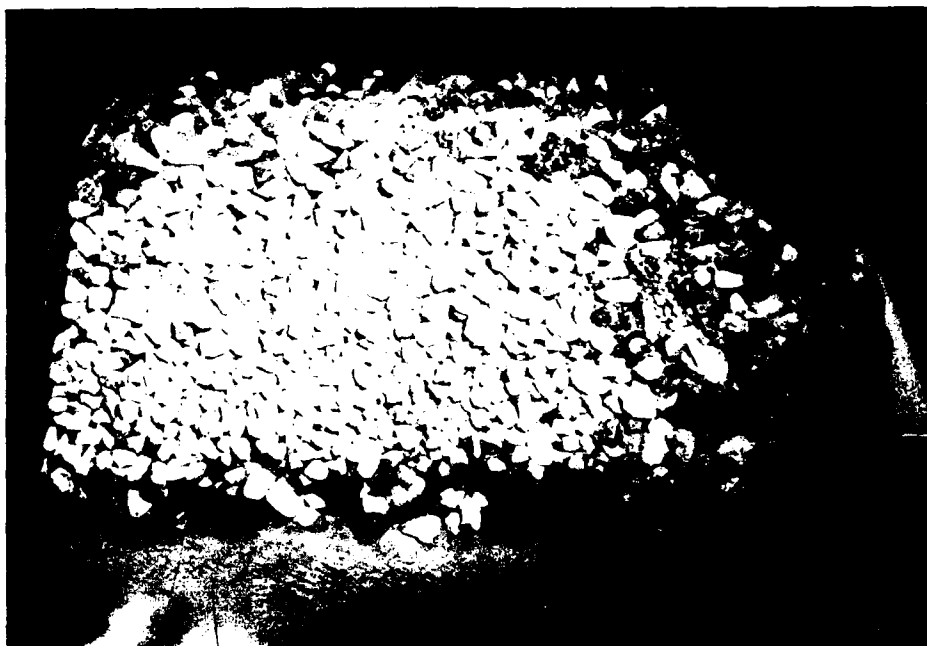
Photo 33. Plan 5, after '4-ft waves, harbor-side view
